Arboricultural Report

Tree Condition Survey

Little Easton Playing Field
Manor Road,
Little Easton,
Dunmow,
Essex,
CM6 2JR.

Ref no: 09/202112

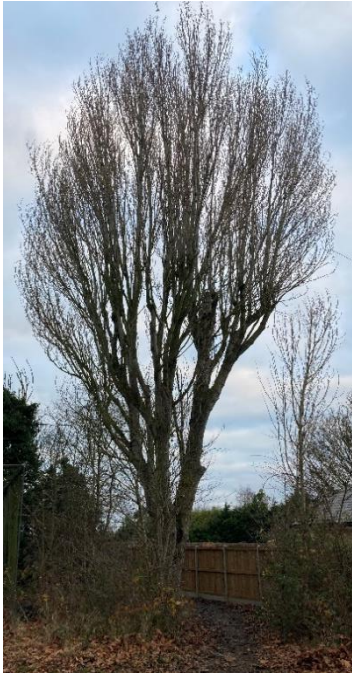
Tree No:	Species:	Height: (m)	Crown Spread dia.: (m)	Stem dia.: (mm)	Age:	Physical condition:	Observations and structural condition of tree(s):	Targets:	Risk rating:	Recommendations of works:	Work priority:	Inspection frequency:
T401	Lombardy Poplar	19	12	800	M	Good	Tree located adjacent to footpath to east. Damage to surface root projecting east due to footfall, exposed desiccated wood visible. Not currently considered significant. Light ivy encroachment on main stem to north and west. Crown breaks into 3no. upright stems at 3m above ground level. Branch unions appear currently stable. <5% major and minor deadwood throughout crown. Historically topped at approx. 8-9m, now with 10m regrowth. Visible decay at several pruning points.	Footpath, cricket netting area, adjacent property west.	Low	Remove major deadwood >50mm in diameter throughout crown. Pollard at 7m above ground level and maintain on a regular 2 year pruning cycle.	12 months all	36 months

Photo 1: T401 Lombardy Poplar as viewed from the south.

Tree No.	Species	Recommendations of works	Timescale
T401	Lombardy Poplar	Remove major deadwood >50mm in diameter throughout crown. Pollard at 7m above ground level and maintain on a regular 2 year pruning cycle.	12 months all
T417	Horse Chestnut	Remove major deadwood throughout crown and prune canopy to provide 1.5m clearance from utilities cable.	12 months
T418	Wild Cherry	Fell tree and replant with a suitable native species specimen.	12 months
T419	English Oak	Remove major deadwood >50mm in diameter overhanging footpath.	12 months
G4	Group of Horse Chestnut	Remove major deadwood >50mm in diameter throughout all crowns.	12 months

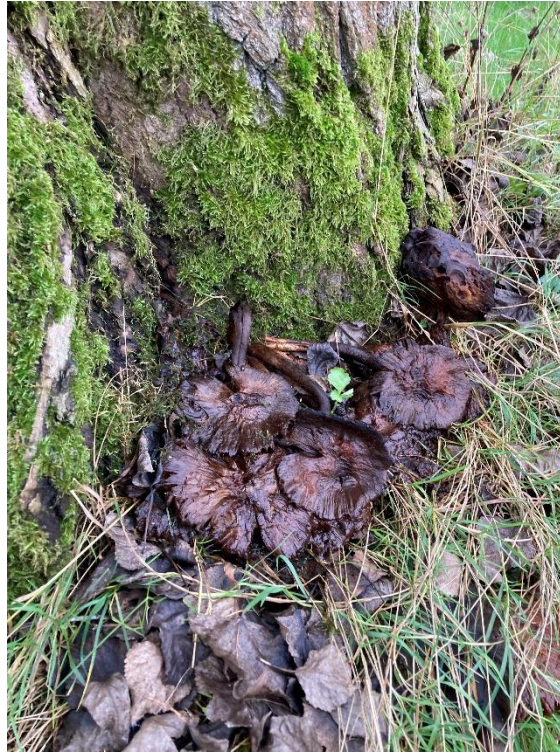
T415	Lombardy Poplar	18	7	930	M	Fair	Senescent fruiting bodies most closely resembling those of the <i>Armillaria spp</i> attached to north, east and southeast of the main stem at ground level. Area probed adjacent fruiting bodies to east to a depth of 80mm. <5% major deadwood within crown. Historically, pollard at 15m, now with 3m regrowth.	Playing field, manor road, properties	Moderate	Re-inspect within summer to confirm identification of colonising pathogen. Remove major deadwood >50mm in diameter throughout crown.	6 months all	36 months
T416	Horse Chestnut	10	8	500	EM	Good	Historically reduced at 9m above ground level, now with <1m regrowth. Good form and crown structure. <5 minor deadwood.	Playing field, manor road, car park	Low	No works presently required.	N/a	36 months
T417	Horse Chestnut	11	7	460	EM	Good	Compaction of soils surrounding tree due to location within centre of car park. Crown historically lifted to 4m, pruning wounds displaying signs of partial occlusion. Crown in direct contact with utilities cable to west. <5% major deadwood in crown.	Car park	Low	Remove major deadwood throughout crown and prune canopy to provide 1.5m clearance from utilities cable.	12 months	36 months

Photo 5: Example of senescent fruiting bodies most closely resembling those of the *Armillaria* spp at the base of T415 Lombardy Poplar.

Tree No.	Species	Recommendations of works	Timescale
T407	Lombardy Poplar	Re-inspect within summer to confirm identification of colonising pathogen.	6 months
T415	Lombardy Poplar	Re-inspect within summer to confirm identification of colonising pathogen. Remove major deadwood >50mm in diameter throughout crown.	6 months all

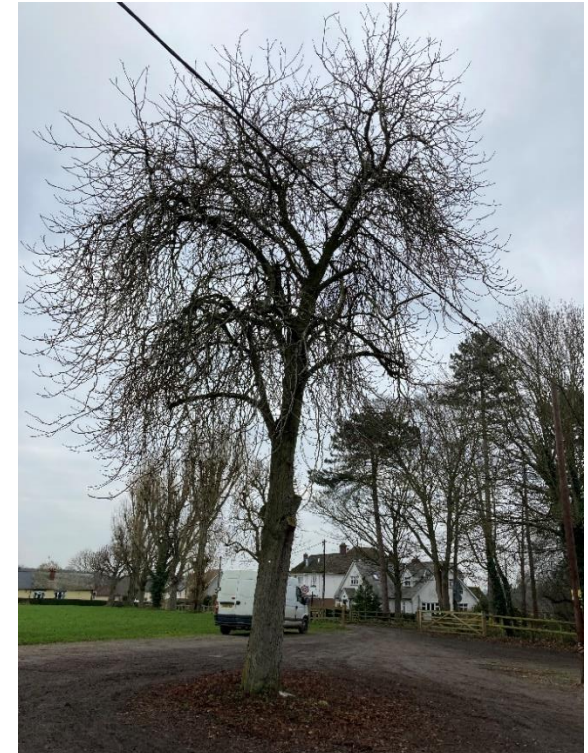
Photo 6: T417 Horse Chestnut with crown in contact with utilities cable as viewed from the west.

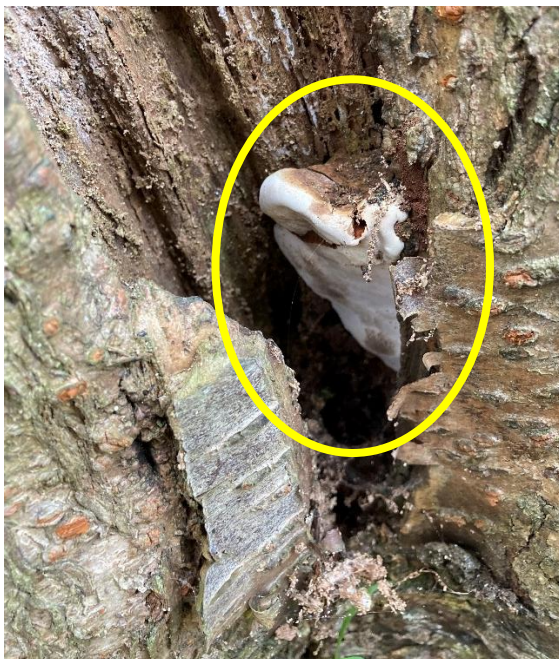
T418	Wild Cherry	6	7	230	EM	Fair	Large historic wound on main stem to north. Visible exposed desiccated wood with fruiting bodies of <i>Ganoderma spp</i> present. Tight included bark unions at crown break 1m above ground level. Crown historically lifted and reduced.	Playing field	Low	Fell tree and replant with suitable native species specimen.	12 months	N/a
T419	English Oak	12	14	990	M	Fair	Located west of ditch line, ownership unknown. Pronounced buttress root formation to west. Hammer resonates hollowing of main stem at 1.5m to northeast and ground level to south. Lack of structural root formation south. Area between structural roots to	Playing field, parish hall	Low	Remove major deadwood >50mm in diameter overhanging footpath.	12 months	36 months

Photo 7: Example of fruiting body of *Ganoderma spp* (highlighted in yellow) located on T418 Wild Cherry.

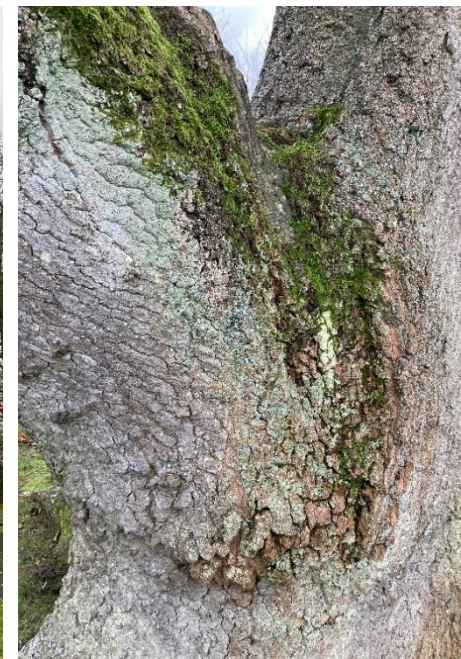
Photo 9: Showing T421 Oak with branch union at 1.5m. Directly below union are signs of stress indicating fibre buckling.

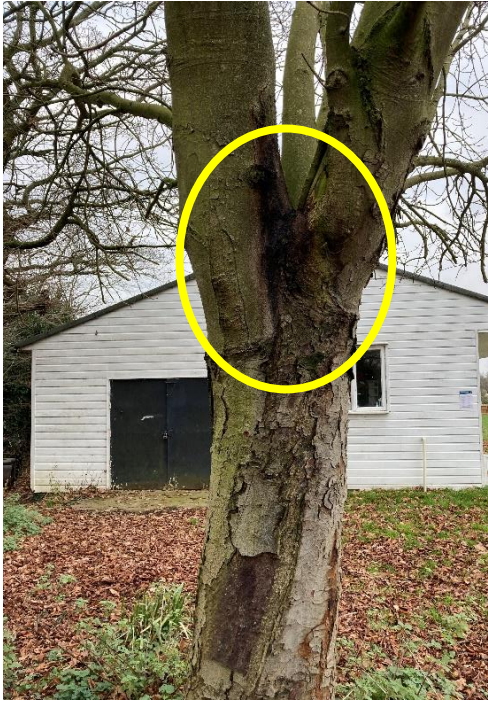
G4	Group of Horse Chestnut	11	10	520	EM	Fair	<p>Group of 2no. even aged Horse Chestnut. Both trees displaying signs of bleeding on their main stems. Bleeding associated with bacterial wet wood infection.</p> <p>Tree to west has dieback of several laterals in inner canopy. Branch union to north at 3m displaying signs of movement. Low target area below.</p> <p>Tree to east has a 100mm diameter wound at the branch union of lateral to southwest at 2.5m. Signs of partial occlusion. Major deadwood within crowns.</p>	Play area	Low	Remove major deadwood >50mm in diameter throughout all crowns.	12 months	18 months
G5	Mixed species group	13	6	350	SM-EM	Fair	<p>Heights range from 3-13m. Mixed group of relatively even aged trees. Species include Field Maple, Oak with an understory of Blackthorn, Elm and Hawthorn. Several dead or declining Elm within group. 1no. Blackthorn with fruiting bodies of <i>Phellinus pomaceus</i> colonising declining stems, not currently considered significant due to low target area and low wind exposure.</p>	Footpath, play area	Low	No works presently required.	N/a	36 months

Photo 10: Example area of bleed (highlighted in yellow) on Horse Chestnut within G4 as viewed from the southwest. Bleed is associated bacterial wet wood infection.

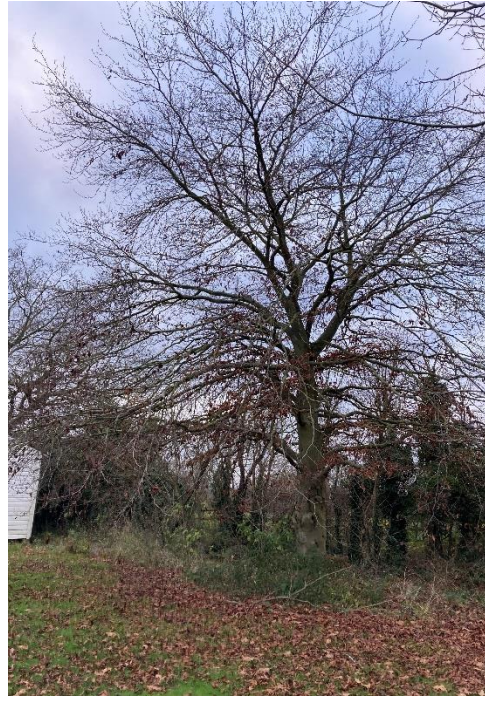
Photo 11: T423 Common Beech as viewed from the southeast.

Tree No.	Species	Recommendations of works	Timescale
T407	Lombardy Poplar	Re-pollard at previous pruning points, approx. 10-11m above ground level.	24 months
T408	Lombardy Poplar	Re-pollard at previous pruning points, approx. 10-11m above ground level.	24 months
T411	Lombardy Poplar	Re-pollard at previous pruning points, approx. 15m above ground level.	24 months
T414	Lombardy Poplar	Re-pollard at previous pruning points, approx. 15m above ground level.	24 months
T421	Oak	Selectively reduce lateral spread of crown to south by approx. 2m to reduce weight on branch union at 1.5m.	24 months
T423	Common Beech	Remove major deadwood >50mm in diameter throughout crown.	24 months

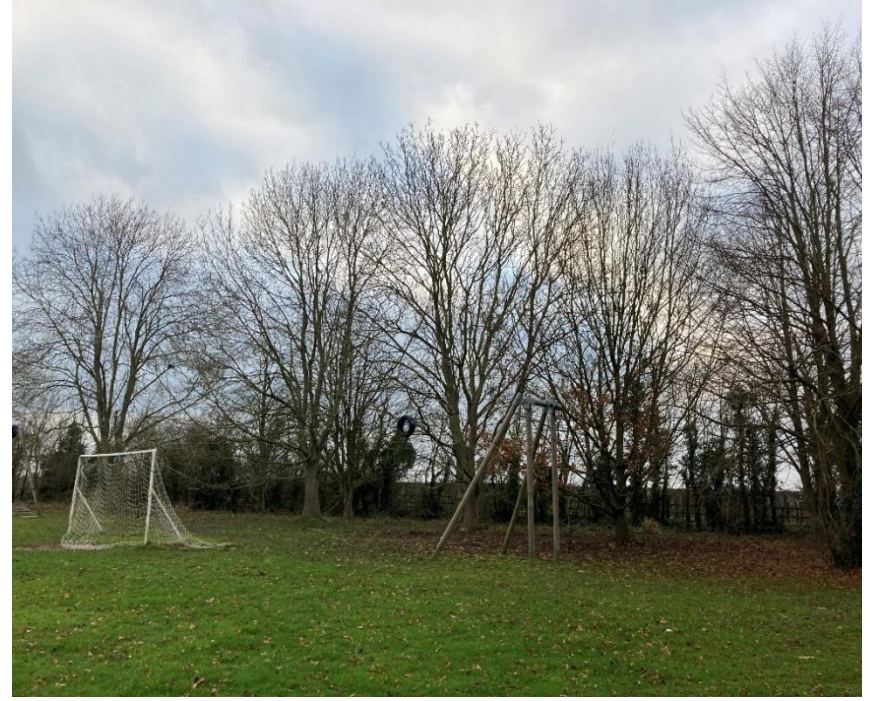
G6	Mixed species group	15	12	600	SM-M	Good	<p>Measurements taken from largest tree within group. Mixed species group. Species include Ash, Oak, Chestnut and Lime. Approx. 12no. trees within group. Major and minor deadwood throughout crowns. 1no. Common Ash within group has damage to stem at 1.5m above ground level to southwest. Unable to probe wound. Not currently considered significant.</p>	Play area, footpath, zip wire apparatus	Moderate	Remove major deadwood >50mm in diameter throughout crowns.	3 months	36 months

Photo 12: G6 (foreground) and G5 (background).

Tree No.	Species	Recommendations of works	Timescale
T407	Lombardy Poplar	Remove major deadwood >50mm in diameter throughout crown.	3 months
T408	Lombardy Poplar	Remove major deadwood >50mm in diameter throughout crown.	3 months
T414	Lombardy Poplar	Remove major deadwood >50mm in diameter throughout crown.	3 months
T421	Oak	Remove major deadwood >50mm in diameter throughout crown.	3 months
T422	English Oak	Remove major deadwood >50mm in diameter throughout crown.	3 months
G2	Mixed species group	Remove major deadwood >50mm in diameter throughout crown.	3 months
G3	Mixed species group	Remove major deadwood >50mm in diameter throughout crown.	3 months
G6	Mixed species group	Remove major deadwood >50mm in diameter throughout crown.	3 months
