Arboricultural Report

Tree Condition Survey

Little Easton Playing Field
Manor Road,
Little Easton,
Dunmow,
Essex,
CM6 2JR.

Ref no: 09/202112

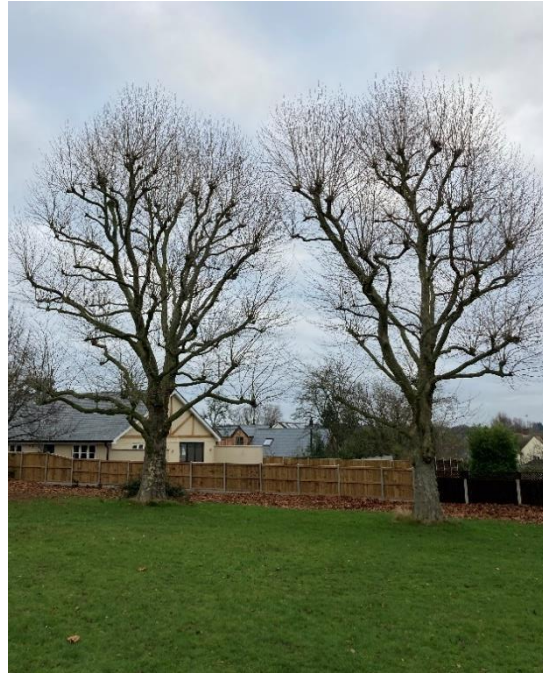
Photo 2: T403 and T404 London Plane as viewed from the southwest.

Tree No.	Species	Recommendations of works	Timescale
T402	Common Lime	Monitor included bark unions to note any movement or crack formation.	36 months
T403	London Plane	Re-pollard at previous pruning points, approx. 12m above ground level.	36 months
T404	London Plane	Re-pollard at previous pruning points, approx. 10m above ground level.	36 months
T405	Lombardy Poplar	Re-pollard at previous pruning points, approx. 10m above ground level.	36 months
T406	London Plane	Re-pollard at previous pruning points, approx. 11m above ground level.	36 months
T409	London Plane	Re-pollard at previous pruning points, approx. 9m above ground level.	36 months
T410	Horse Chestnut	Re-pollard at previous pruning points, approx. 8m above ground level.	36 months
T412	Horse Chestnut	Reduce height and lateral spread of crown to previous pruning points.	36 months

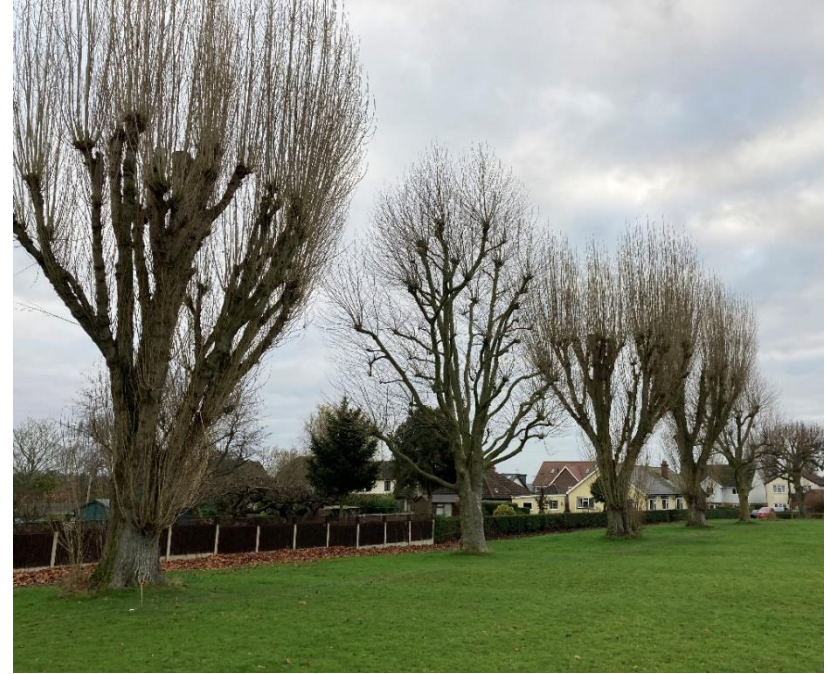
T405	Lombardy Poplar	14	8	960	M	Good	Basal and epicormic growth attached to main stem. Historic wound on main stem at ground level to east. Visible decay, probed to a depth of 100mm. Adventitious root growing adjacent area of decay. Not currently considered significant. Historically pollard at 10m, now with 4m regrowth. Visible decay and desiccated wood present at historic pruning points. Minor storm damaged branches, <20mm diameter, within canopy. Presents low risk, not considered significant.	Playing field	Low	Re-pollard at previous pruning points, approx. 10m above ground level.	36 months	36 months
T406	London Plane	13	10	880	M	Good	Crown breaks into 2no. stems at 2.5m above ground level. Swelling of stem directly below union. Union appears currently stable, not currently considered significant. Historically pollard at approx. 11m, now with 2m regrowth.	Playing field	Low	Re-pollard at previous pruning points, approx. 11m above ground level.	36 months	36 months

T407	Lombardy Poplar	16	9	960	M	Good	Damage to buttress root to west, suspected mechanical damage. Senescent fungal fruiting bodies present on main stem at ground level to east. Unable to probe areas adjacent to fruiting bodies. Fruiting bodies most closely resemble those of the <i>Armillaria</i> spp. Considered to be currently acting saprophytically. Pruning wound on main stem at 2m to north, visible desiccated and decay within cavity, unable to probe, signs of partial occlusion. Not currently considered significant. Historically pollard at 10-11m above ground level, now with 5m regrowth. Visible decay and desiccated wood present at historic pruning points. <5% major deadwood within crown.	Playing field	Moderate	Remove major deadwood >50mm in diameter throughout crown. Re-inspect within summer to confirm identification of colonising pathogen. Re-pollard at previous pruning points, approx. 10-11m above ground level.	3 months. 6 months 24 months	36 months

T408	Lombardy Poplar	17	10	1000	M	Good	Historically crown lifted with several pruning wounds on the main stem from 1.6m to 2.5m. Pruning wounds range from 80-180mm in diameter. Minor amount of basal and epicormic growth attached to main stem. Historically pollard at 10m above ground level, now with approx. 6m regrowth. Visible decay and desiccated wood present at historic pruning points. 2m section of missing bark extending down from pollard point of central stem. Approx. 5% major deadwood within crown including dieback of upright laterals, >200mm diameter.	Playing field	Moderate	Remove major deadwood >50mm in diameter throughout crown. Re-pollard at previous pruning points, approx. 10-11m above ground level.	3 months 24 months	36 months
T409	London Plane	12	9	660	EM	Good	Historically pollard at 9m above ground level, now with 3m regrowth. Good form and crown structure.	Playing field, manor road	Low	Re-pollard at previous pruning points, approx. 9m above ground level.	36 months	36 months

Photo 3: T405 -410 as viewed from the west.

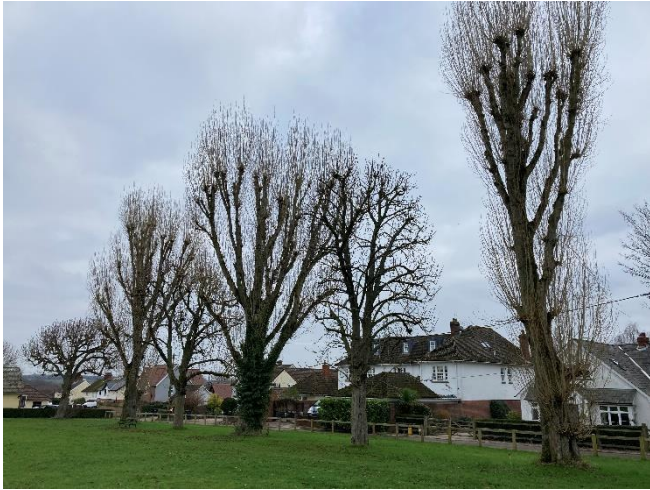
Photo 4: T410 – T415 as viewed from the west.

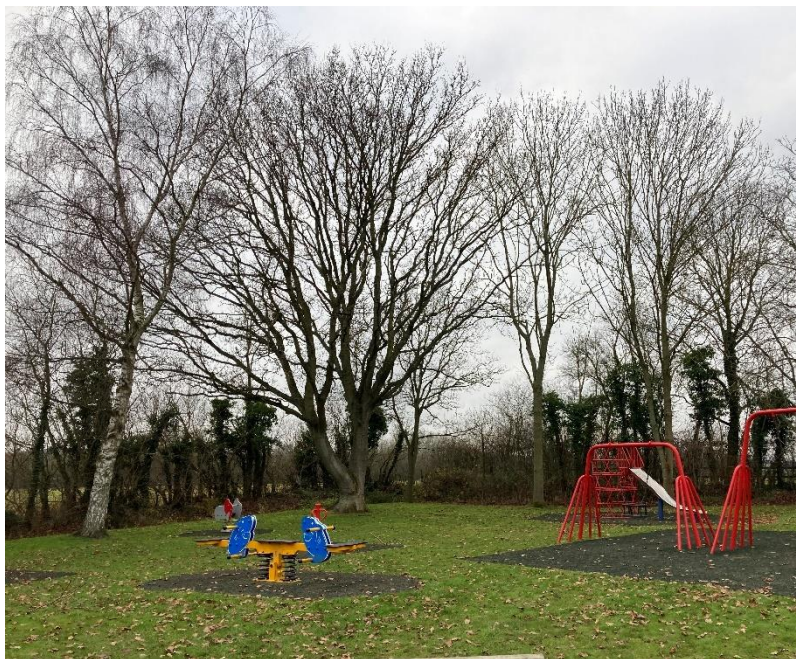
Photo 8: T420 Silver Birch, T421 Oak and G3 Mixed species group as viewed from the southeast.
